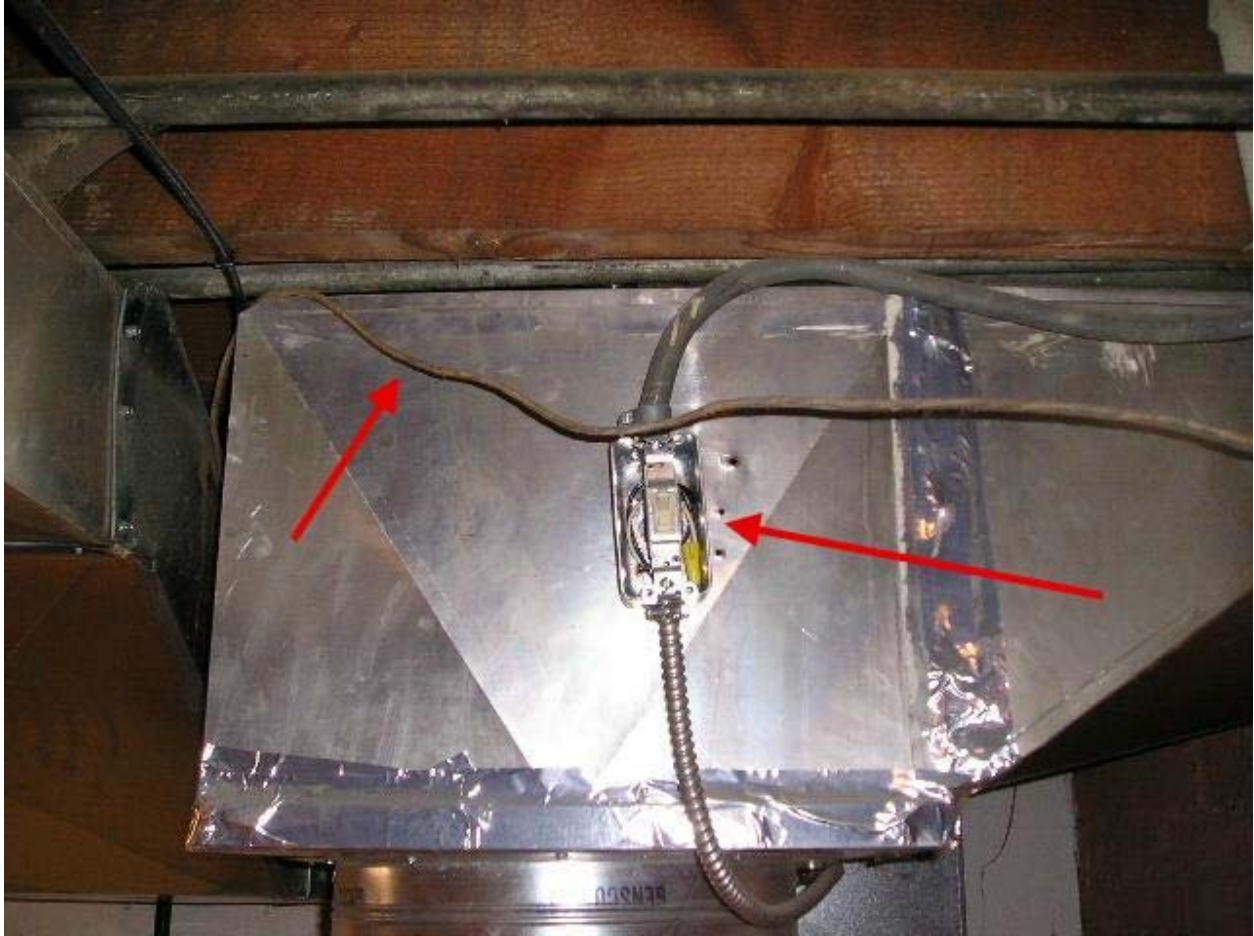
The disconnect switch for the furnace was relocated during replacement and attached to the main plenum. A screw used to attach the junction box, damaged one of the wires and energized the ductwork. It is very lucky that someone was not killed as a result of this unprofessional installation.
