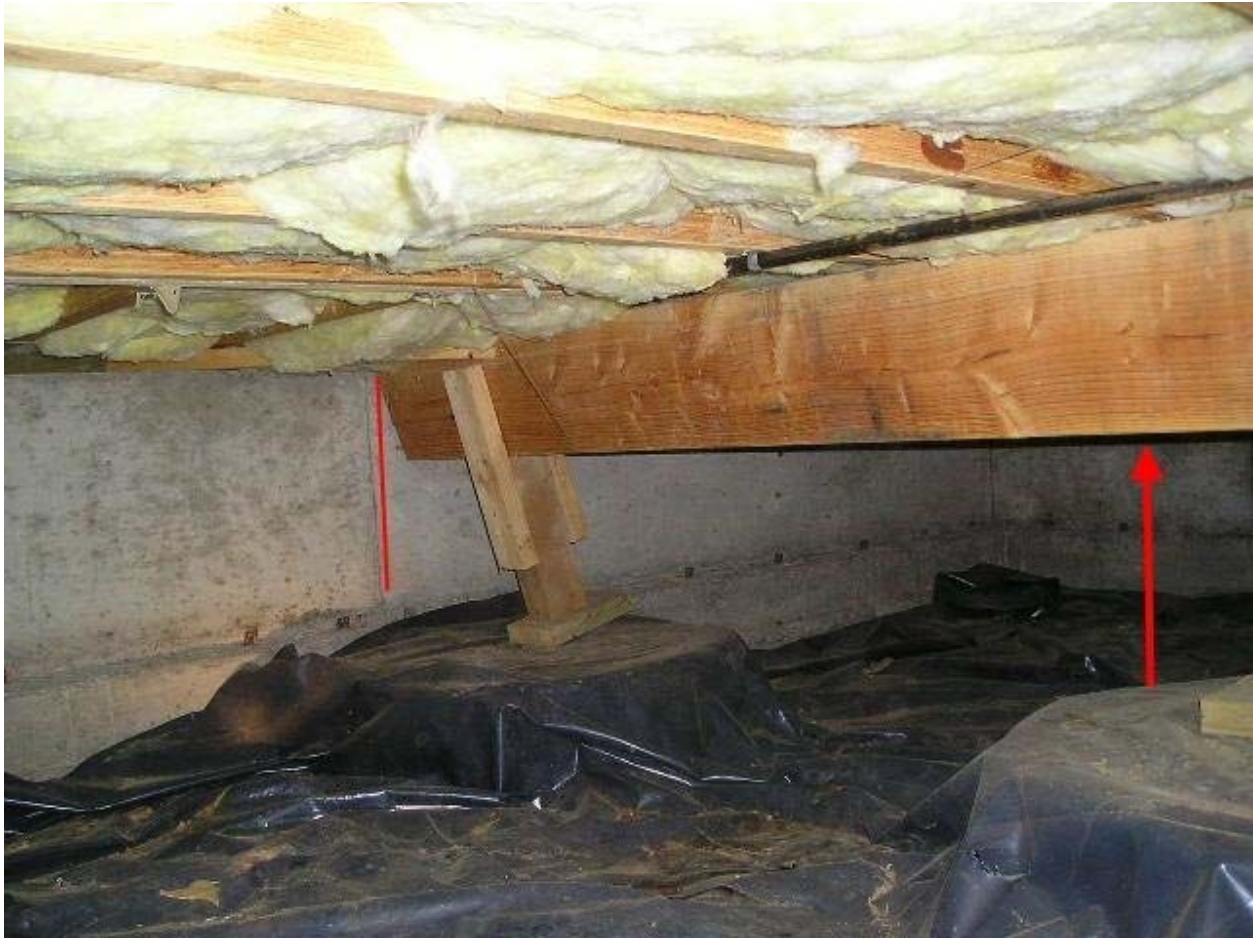
This main beam is located in a 3 year old home. Green lumber was used during construction and as the beam dried, it warped over 4 inches. It was underneath the tile fireplace hearth and causing the grout and tiles to crack. A 10 foot section of the beam was replaced.
