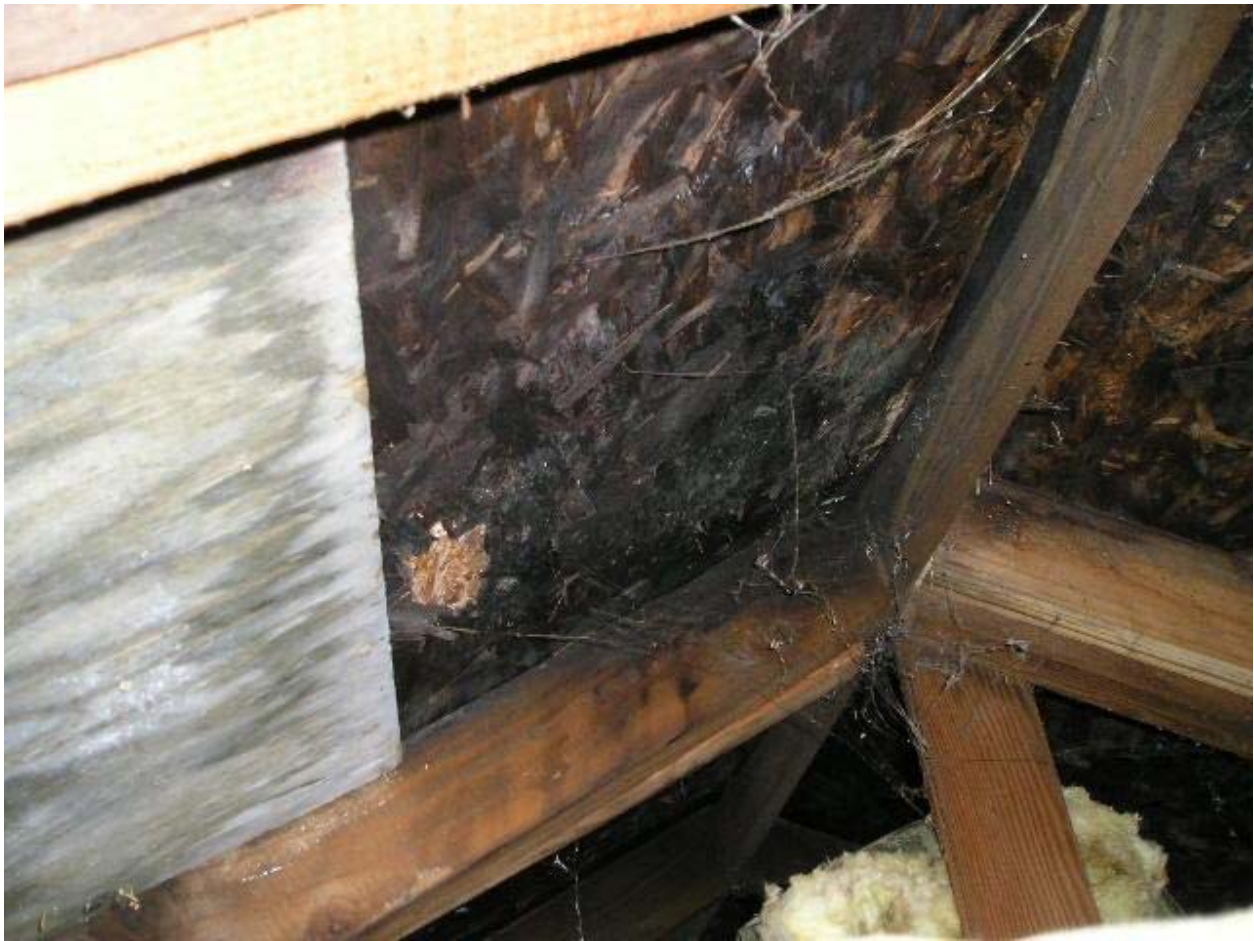
The roof sheathing on this four-plex was saturated. The moisture reading was 100% and there were mushrooms and mold growing throughout the attic area of the top two units. The roof and sheathing were needing replacement and the moisture was also starting to affect the rafters.
