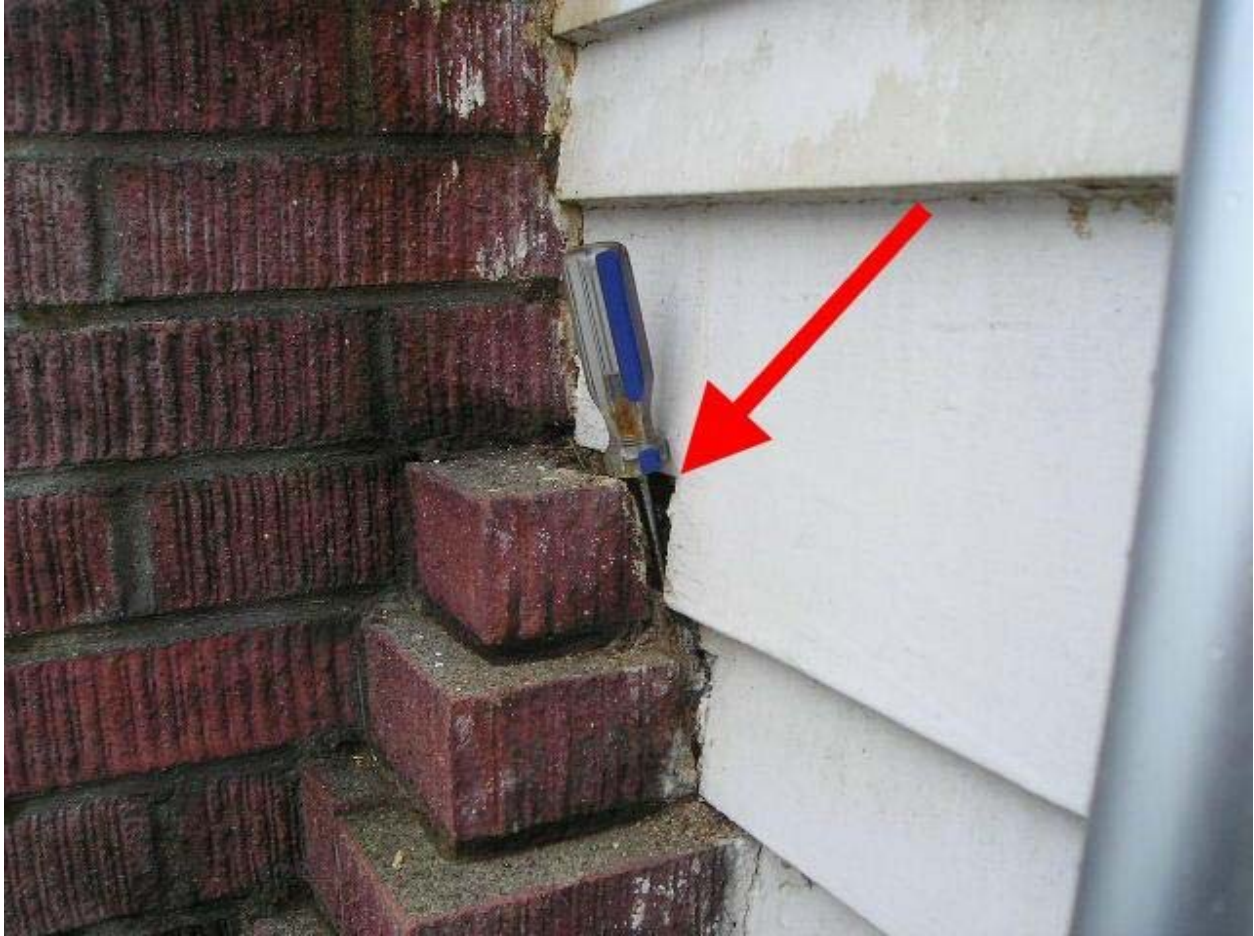
The chimney mortar of this 85 year old home had softened and eroded. Almost the entire chimney had to have the mortar replaced. The hole was allowing water into the wall around the fireplace. The interior paint was starting to discolor and the plaster walls were very moist.
