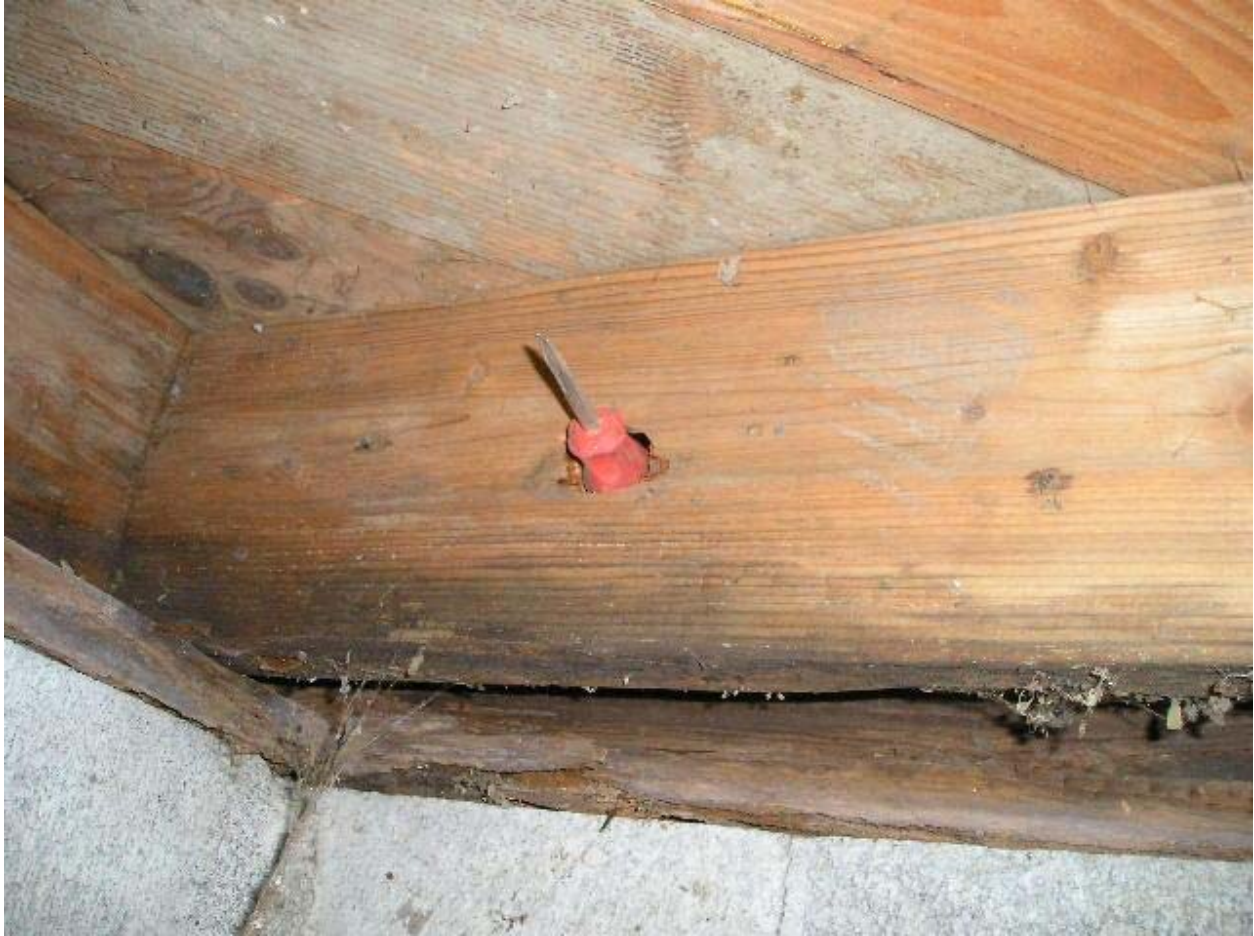
From the side, this floor joist looked to be in good condition. While probing with a screwdriver, it was found that the termite damage was so extensive, the joist was hollow. The screwdriver went all the way through one side and out the other.
