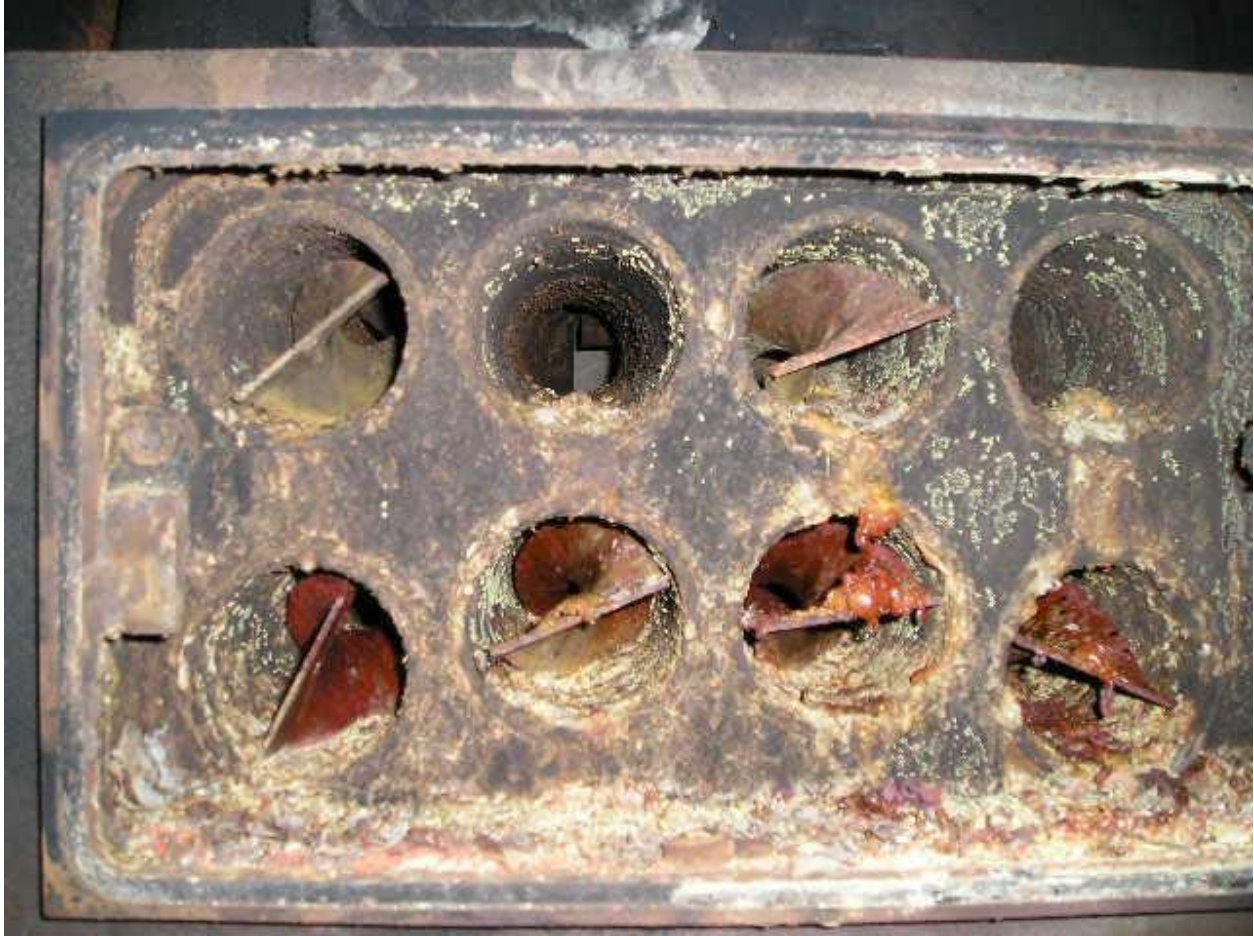
This heating system was a hot water system. This oil burner heat chamber was cracked in numerous areas and had not been serviced in what appears to be decades. Follow-up found that the unit was beyond repair and a new unit was installed.
