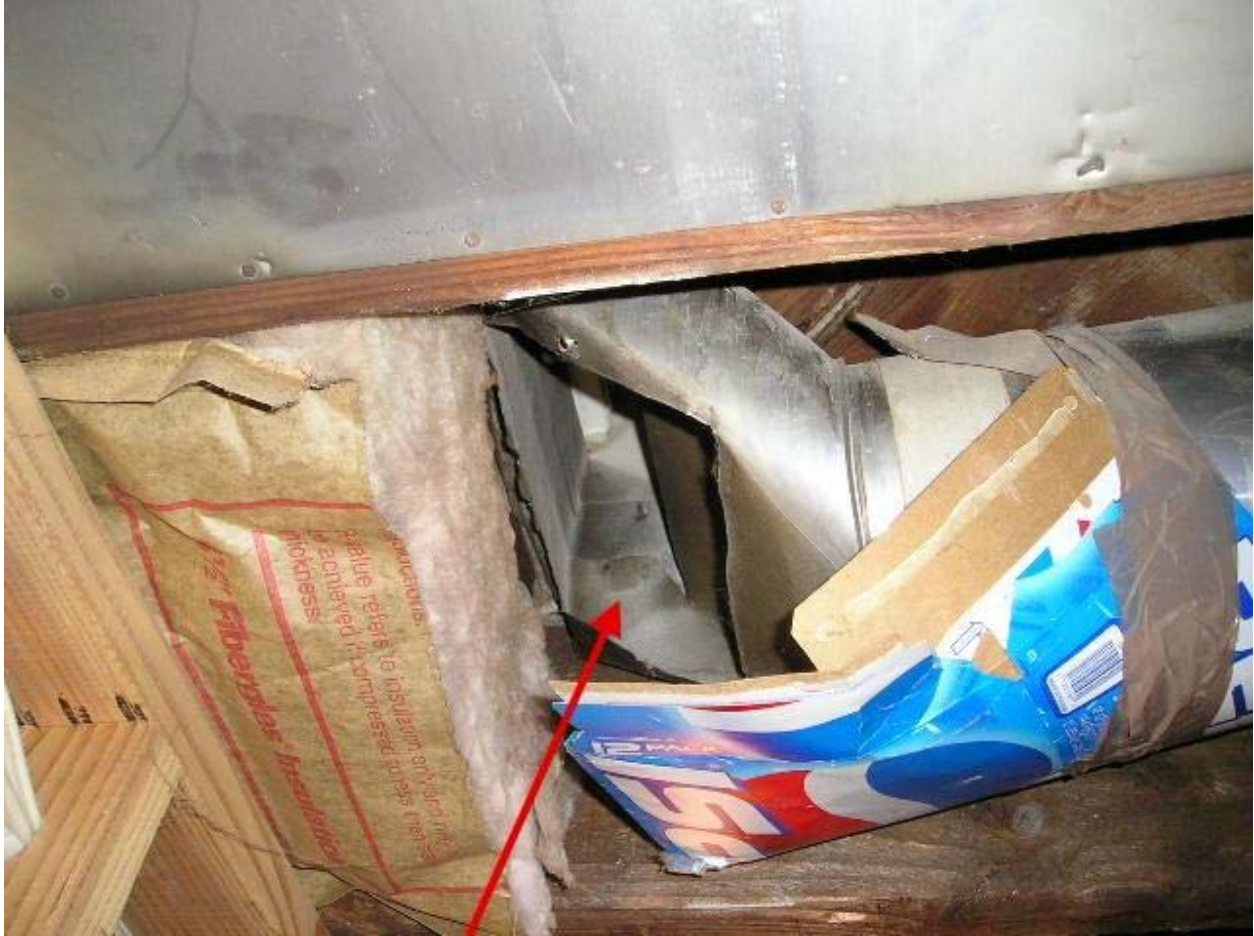
One of the heating ducts was reused in another area. Since it had been previously cut, the installer decided to “patch” the unit with a left over Pepsi carton. This did keep the crawlspace warm, it was the bathroom that was cold.
