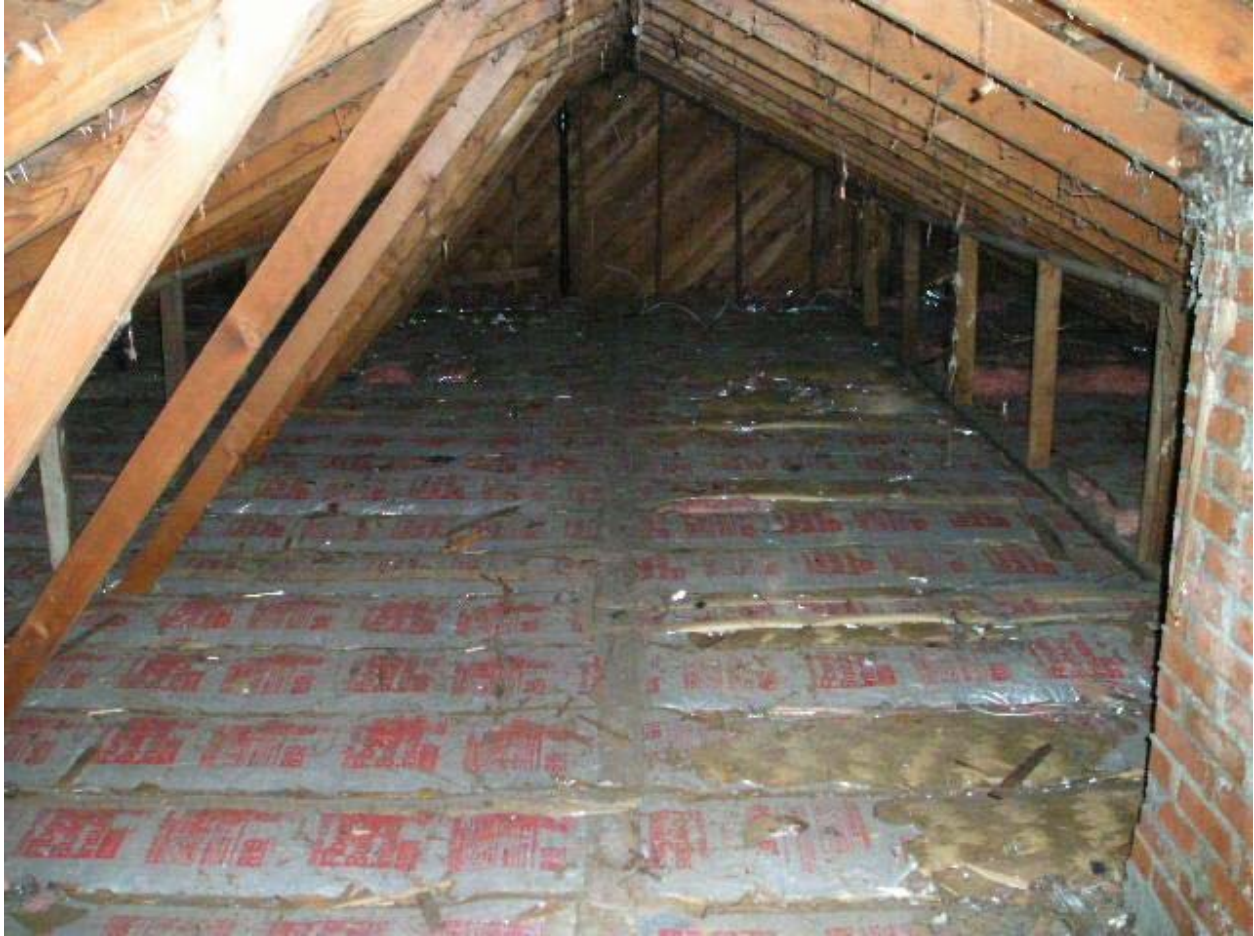
All the insulation in the attic was installed incorrectly. The vapor barrier that is visible should be facing the living space. By installing in this position, condensation can build up within the insulation between the vapor barrier and the ceiling. This could lead to a high moisture area that is subject to mold growth.
