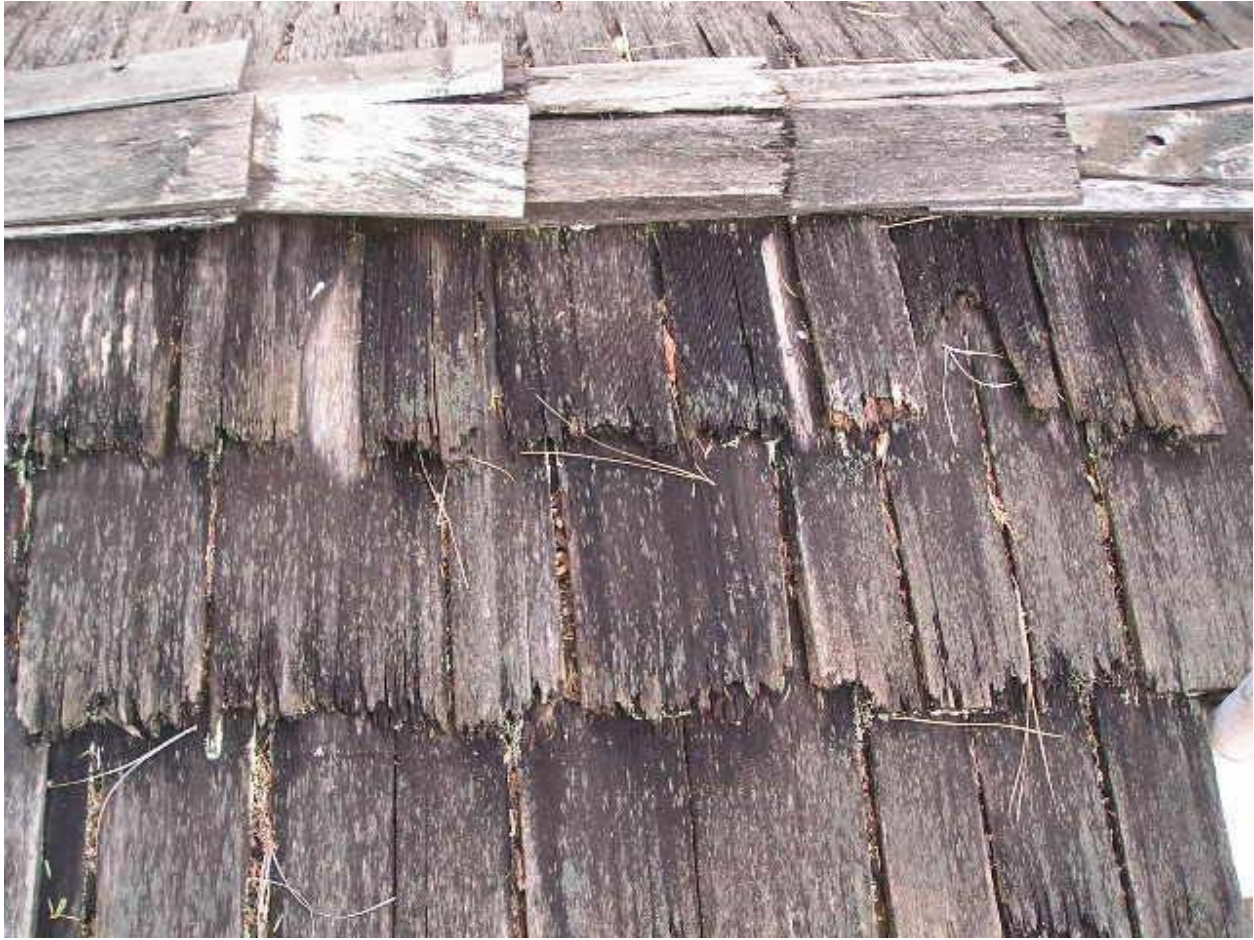
I'm really not sure what to say about this roof. The shingles were so far gone; they would crumble when you poked them with your finger. A new roof was installed.
