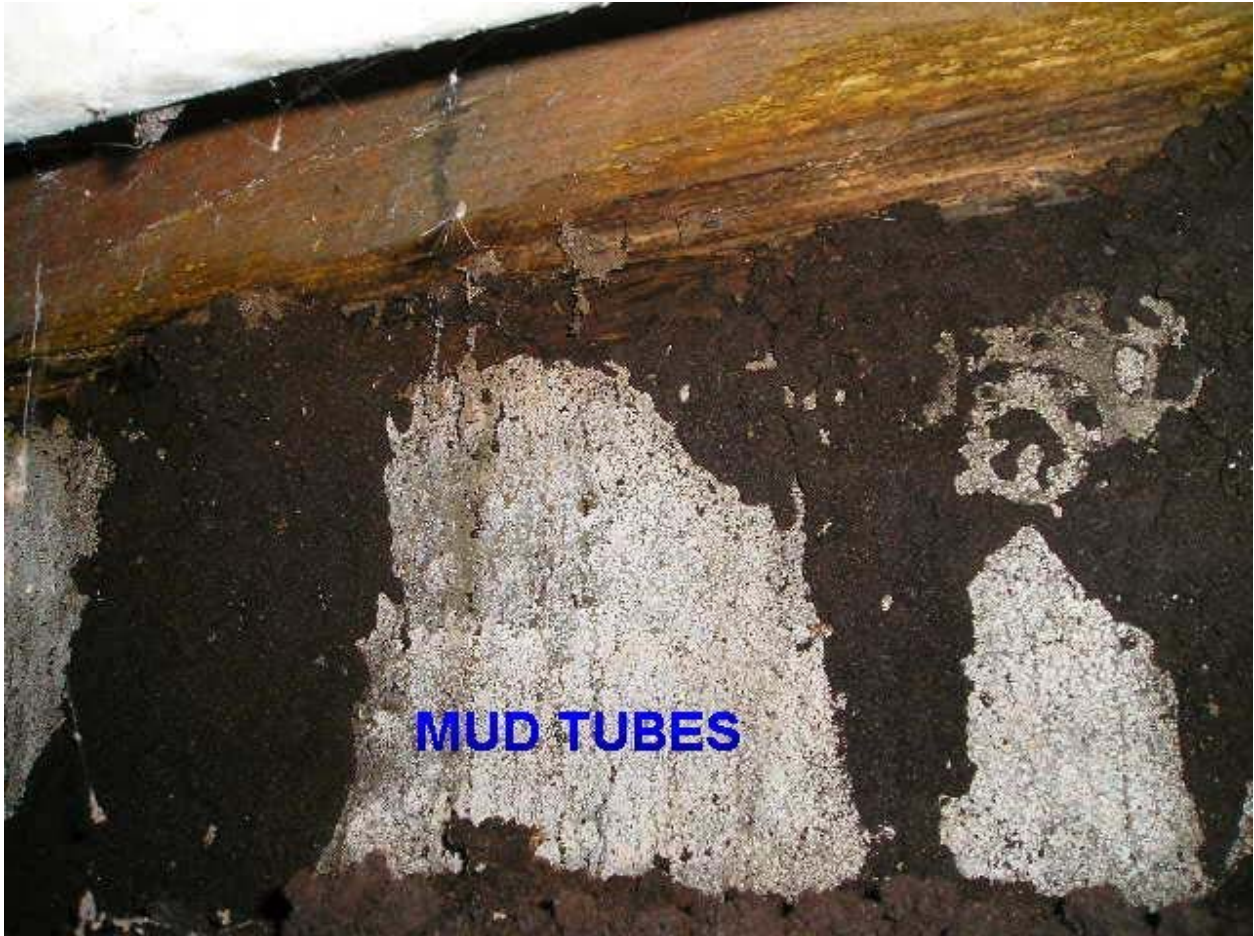
This home had a bad termite infestation at the far end of a very low crawlspace. The complete sill plate was badly damaged and would need replacement. This would entail jacking the home up for repairs. The termites had also moved up into the walls and there were extensive repairs needed.
